TECHNICAL ASSISTANCE TEAM FOR EMERGENCY RESPONSE REMOVAL AND PREVENTION
EPA CONTRACT 68-01-7367

Re: Lyle's Trucking, Belleville, Michigan
TDD# 5-8909-09

On September 9, 1989, the U. S. Environmental Protection Agency (U.S. EPA) tasked the Technical Assistance Team (TAT) to conduct a site assessment and evaluate the threats to human health and environment at the Lyle's Trucking site in Belleville, Wayne County, Michigan (Figure 1). This letter report summarizes the site history, site investigation and analytical results of samples collected by the TAT.

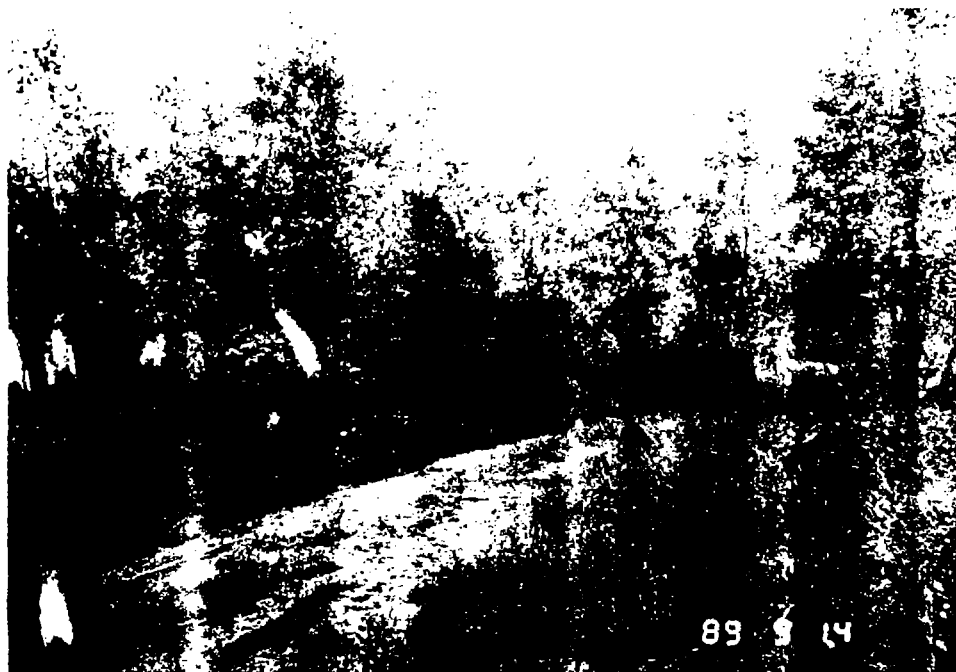
PHOTO ID: 3
 SITE: LYLE'S TRUCKING
 DATE/TIME: 09-14-89 PM
 DIRECTION: WEST
 PHOTOGRAPHER: K. HANSON *KH*
 CAMERA: OLYMPUS INFINITY 35 MM
 SUBJECT: VIEW OF SITE AND DRIVEWAY CONT'D INTO SITE

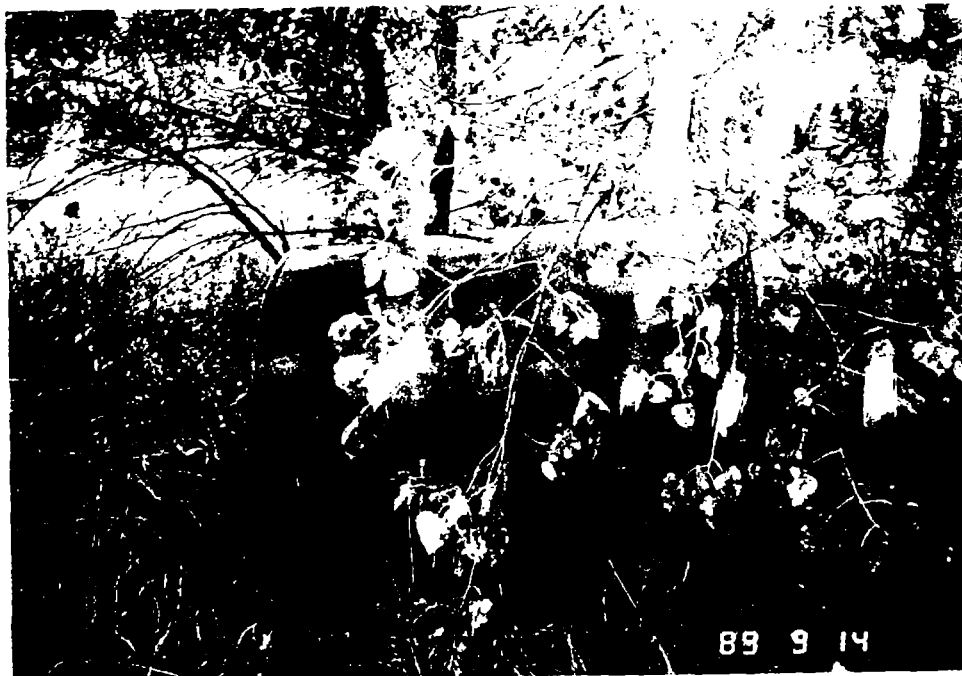
PHOTO NO: 5
 SITE: LYLE'S TRUCKING
 DATE/TIME: 09-14-89 PM
 DIRECTION: WEST
 PHOTOGRAPHER: K. HANLON
 CAMERA: OLYMPUS INFINITY 35 MM
 SUBJECT: TANK PRESENT ON SITE

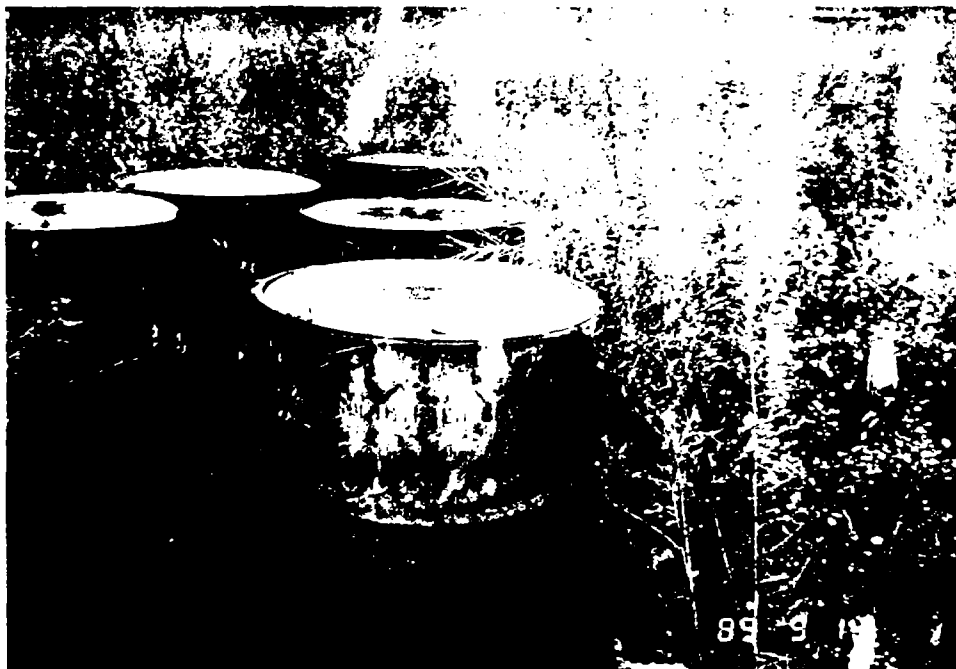
PHOTO NO: 9
 SITE: LYLE'S TRUCKING
 DATE/TIME: 09-14-89/PM
 DIRECTION: NW
 PHOTOGRAPHER: K. HANLOK *KH*
 CAMERA: OLYMPUS INFINITY 35 MM
 SUBJECT: DRUMS PRESENT ON THE NORTHERN PART OF THE SITE

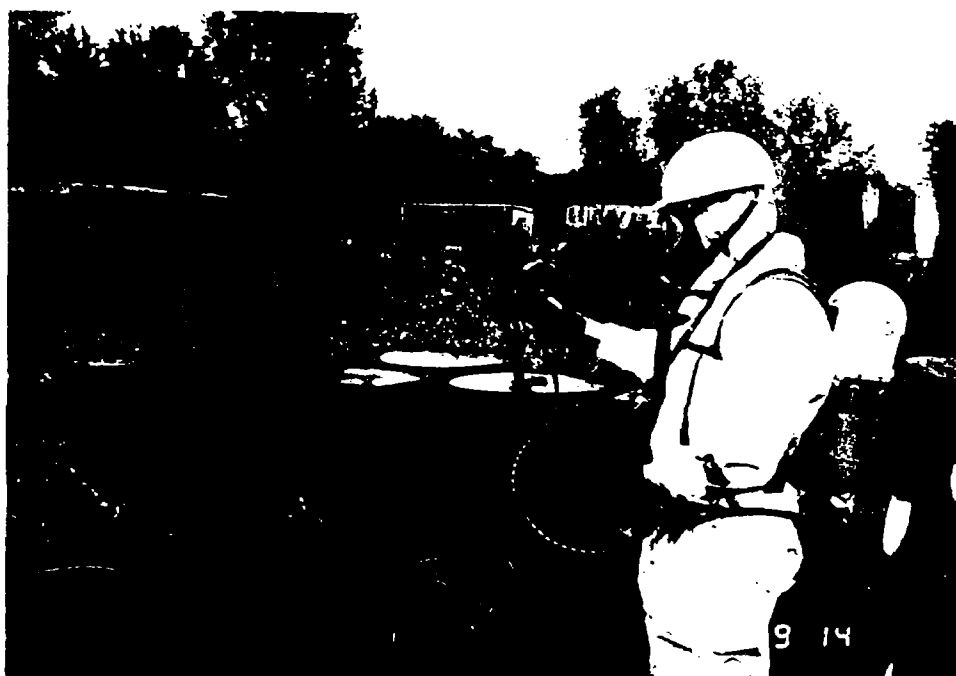
PHOTO NO: 10
 SITE: LYLE'S TRUCKING
 DATE/TIME: 09-14-89/PM
 DIRECTION: NW
 PHOTOGRAPHER: K. HANLOK *KH*
 CAMERA: OLYMPUS INFINITY 35 MM
 SUBJECT: TAT AIR MONITORING DRUMS PRESENT ON THE SITE

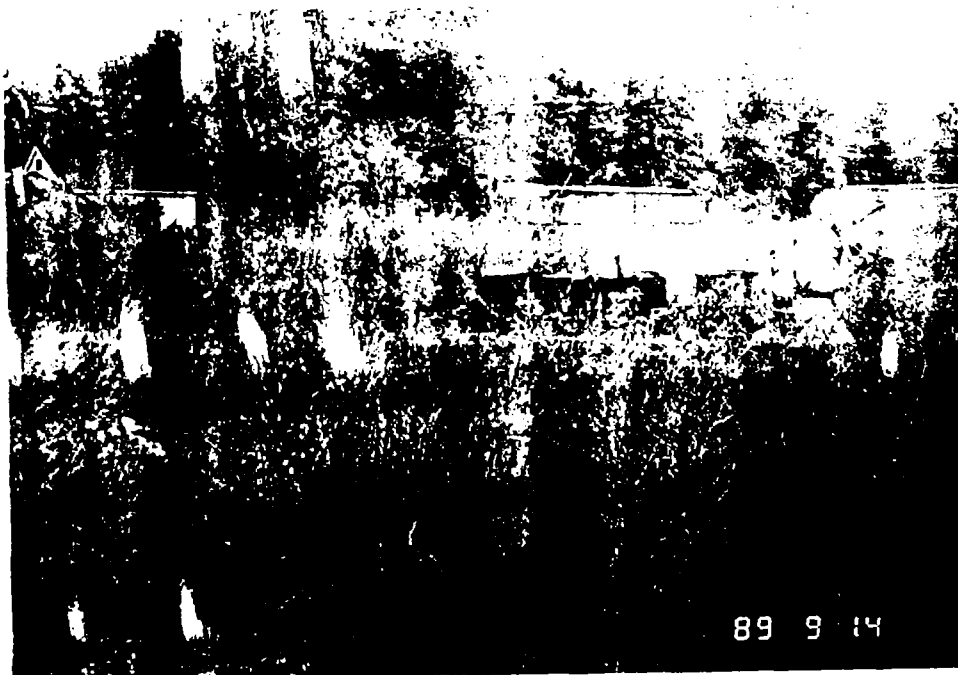
PHOTO NO: 11
 SITE: CYLE'S TRUCKING
 DATE/TIME: 09-14-89/PM
 DIRECTION: NW
 PHOTOGRAPHER: K. HANLON *KH*
 CAMERA: OLYMPUS INFINITY 35 MM
 SUBJECT: VIEW OF THE DRUMS PRESENT ON THE NORTHERN PART OF THE
 SITE AND THE RESIDENCE ADJACENT TO THE SITE

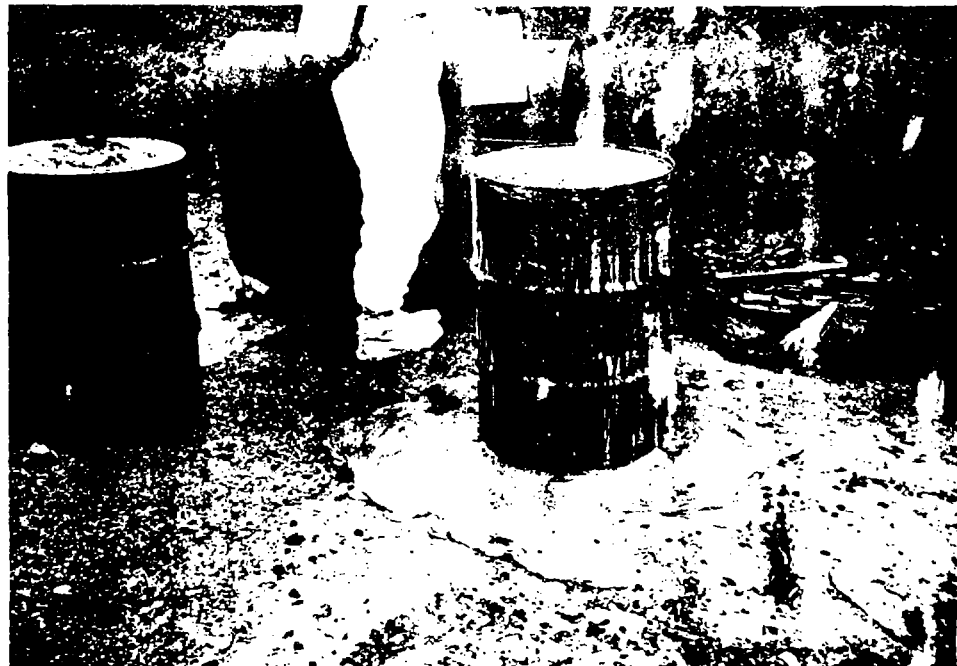
PHOTO NO: 13
 SITE: LYLE'S TRUCKING
 DATE/TIME: 09-14-89 PM
 DIRECTION: SOUTH
 PHOTOGRAPHER: K. HANLOM
 CAMERA: OLYMPUS INFINITY 35 MM
 SUBJECT: DRUM CONTAINING REDDISH BROWN MATERIAL, SHOWED 20-30 PPM
 ON THE OVA

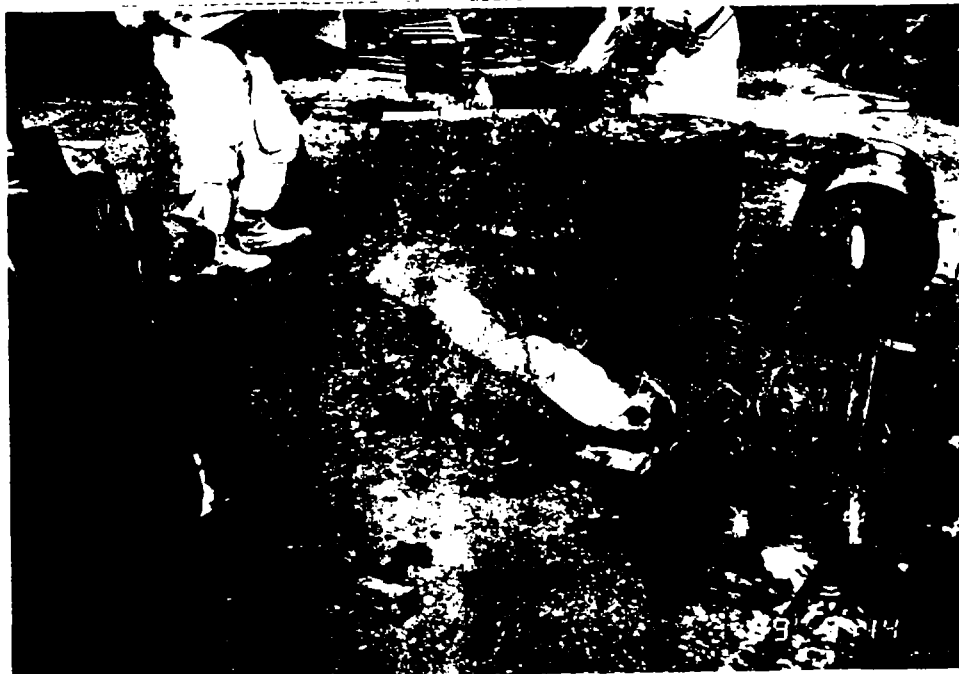
PHOTO NO: 14
 SITE: LYLE'S TRUCKING
 DATE/TIME: 09-14-89 PM
 DIRECTION: SOUTH
 PHOTOGRAPHER: K. HANLOM
 CAMERA: OLYMPUS INFINITY 35 MM
 SUBJECT: DRUM CONTAINING BLUE MATERIAL, SHOWED 60-80 PPM ON THE
 OVA

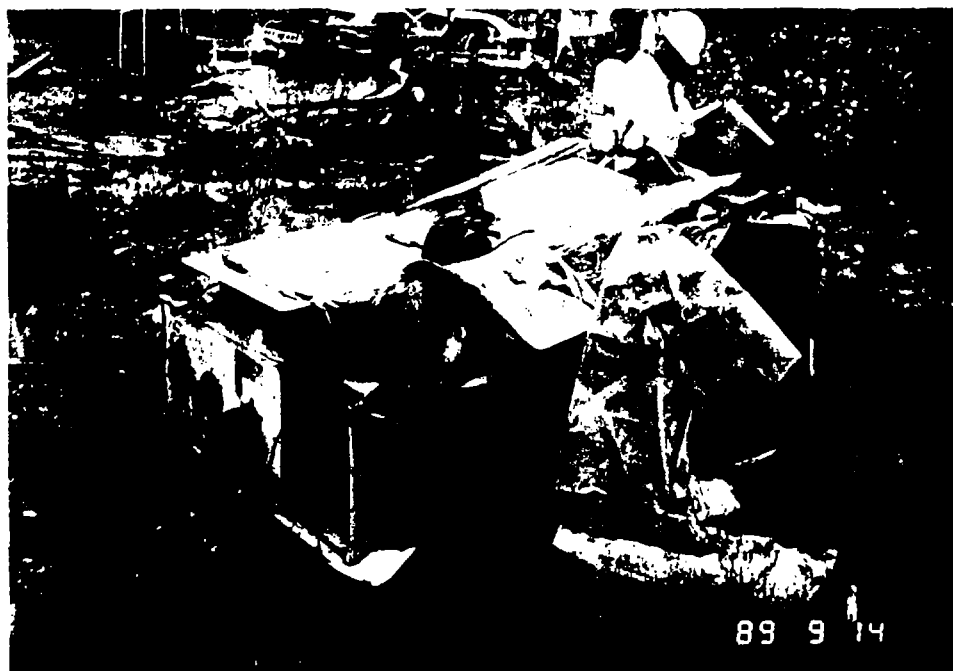
PHOTO NO: 12
 SITE: LYLE TRUCKING
 DATE/TIME: 09-14-89/PM
 DIRECTION: SE
 PHOTOGRAPHER: K. HANLON *KH*
 CAMERA: OLYMPUS INFINITY 35 MM
 SUBJECT: VIEW OF JUNK CARS AND WRECKS FROM THE SITE

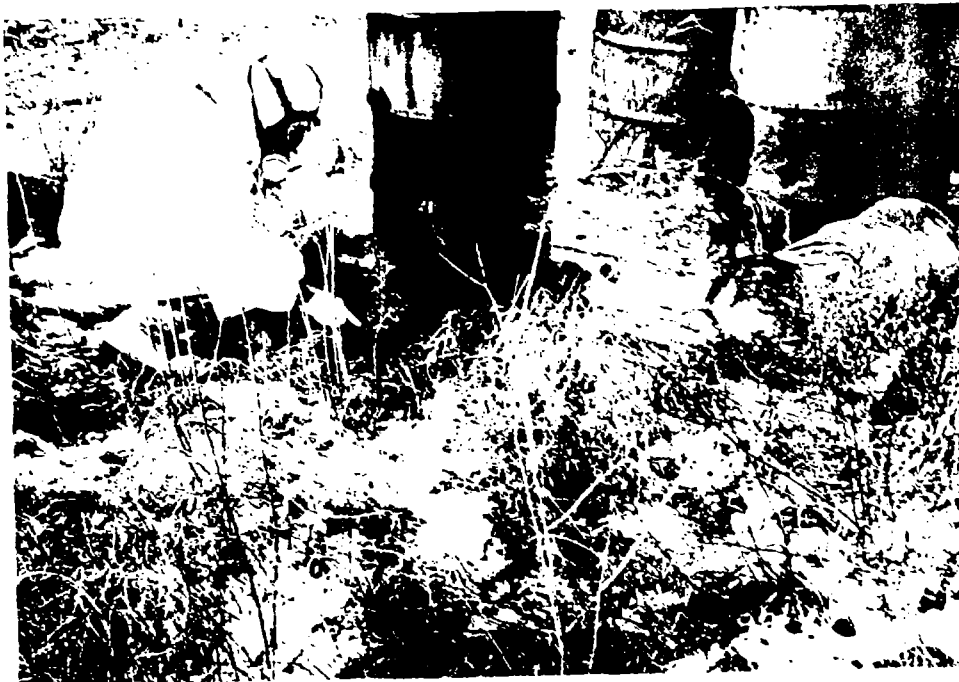
PHOTO NO: 18
 SITE: LYLE'S TRUCKING
 DATE/TIME: 01-12-90/PM
 DIRECTION: NW
 PHOTOGRAPHER: C. KREINDLER ©
 CAMERA: OLYMPUS INFINITY 35 MM
 SUBJECT: TAT COLLECTING SOIL SAMPLE S2

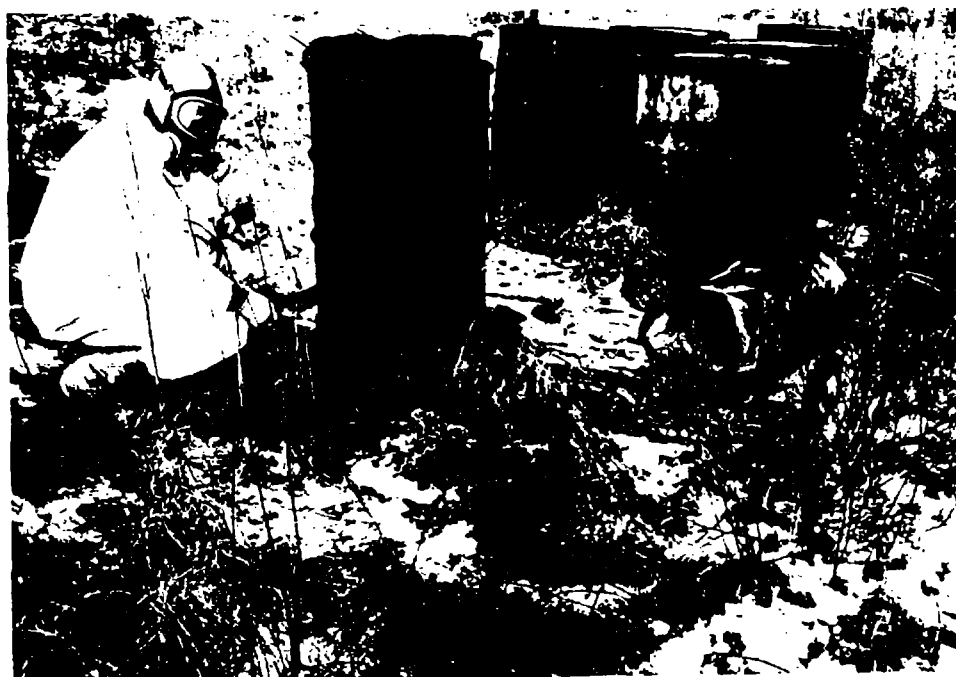
PHOTO NO: 19
 SITE: LYLE'S TRUCKING
 DATE/TIME: 01-12-90/PM
 DIRECTION: NW
 PHOTOGRAPHER: C. KREINDLER ©
 CAMERA: OLYMPUS INFINITY 35 MM
 SUBJECT: TAT COLLECTING SOIL SAMPLE S2

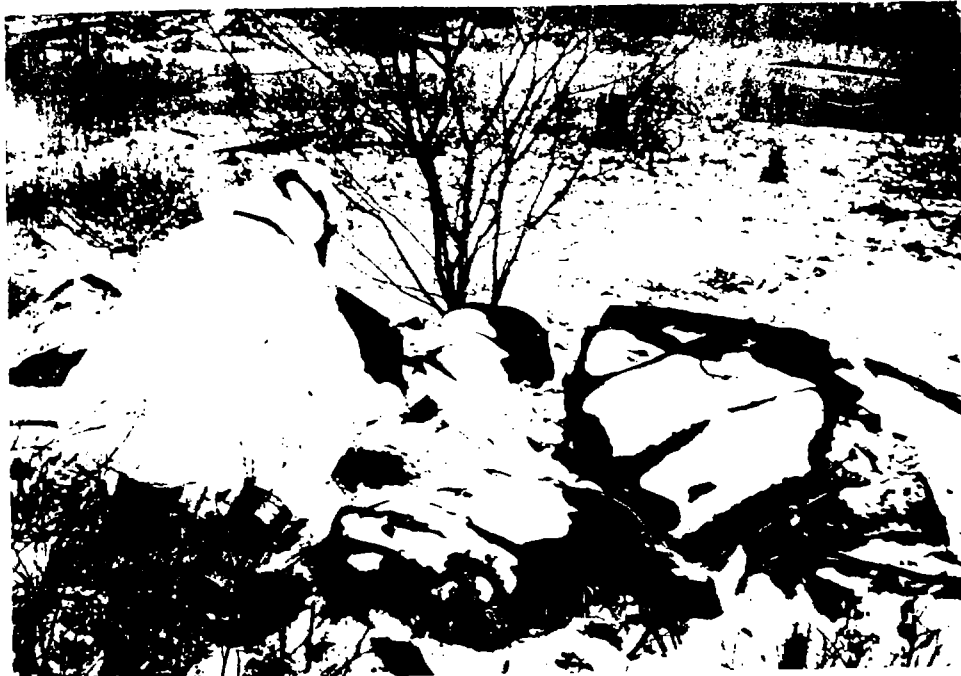
PHOTO NO: 20
 SITE: LYLE'S TRUCKING
 DATE/TIME: 01-12-90/PM
 DIRECTION: SE
 PHOTOGRAPHER: C. KREINDLER
 CAMERA: OLYMPUS INFINITY 35 MM
 SUBJECT: TAT COLLECTING SOIL SAMPLE S1

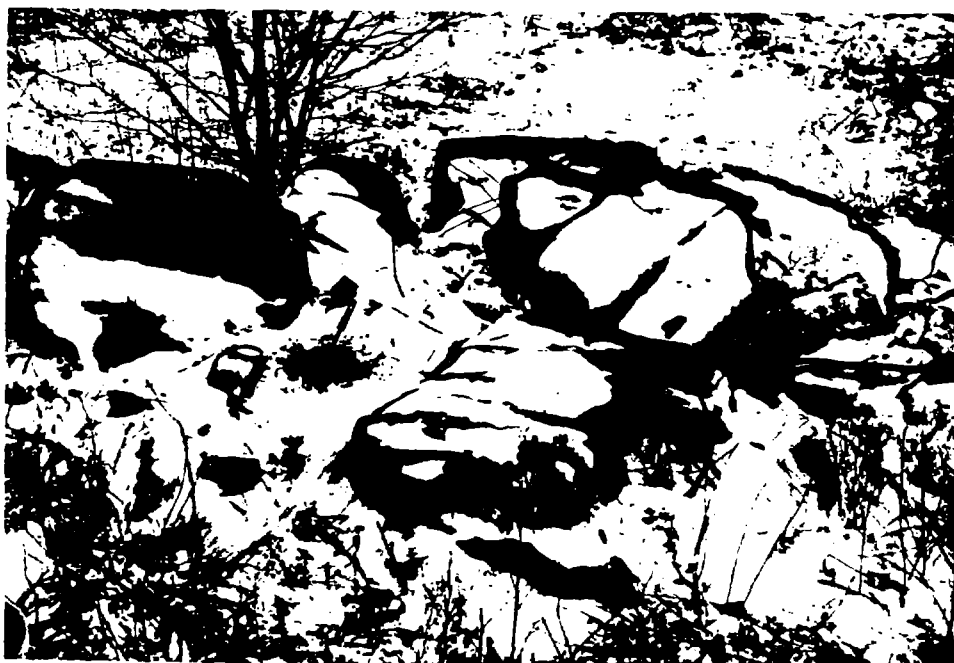
PHOTO NO: 21
 SITE: LYLE'S TRUCKING
 DATE/TIME: 01-12-90/PM
 DIRECTION: SE
 PHOTOGRAPHER: C. KREINDLER
 CAMERA: OLYMPUS INFINITY 35 MM
 SUBJECT: LOCATION OF SOIL SAMPLE S1

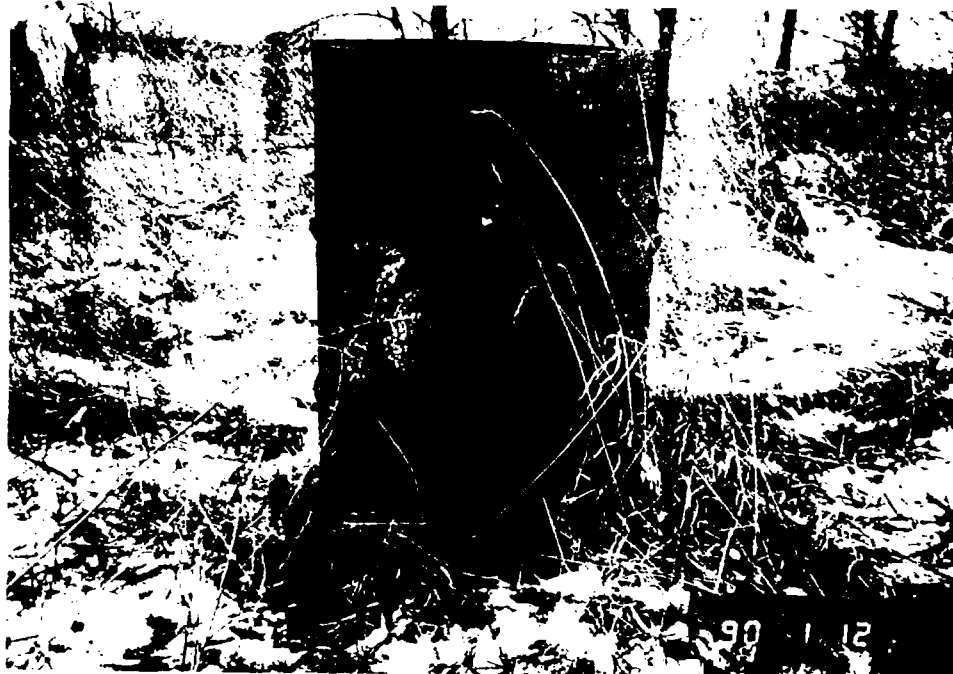
PHOTO NO: 22
 SITE: LYLE'S TRUCKING
 DATE/TIME: 01-12-90/PM
 DIRECTION: SW
 PHOTOGRAPHER: C. KREINDLER
 CAMERA: OLYMPUS INFINITY 1 MM
 SUBJECT: VIEW OF DRUM WITH MATERIAL LEAKING OUT

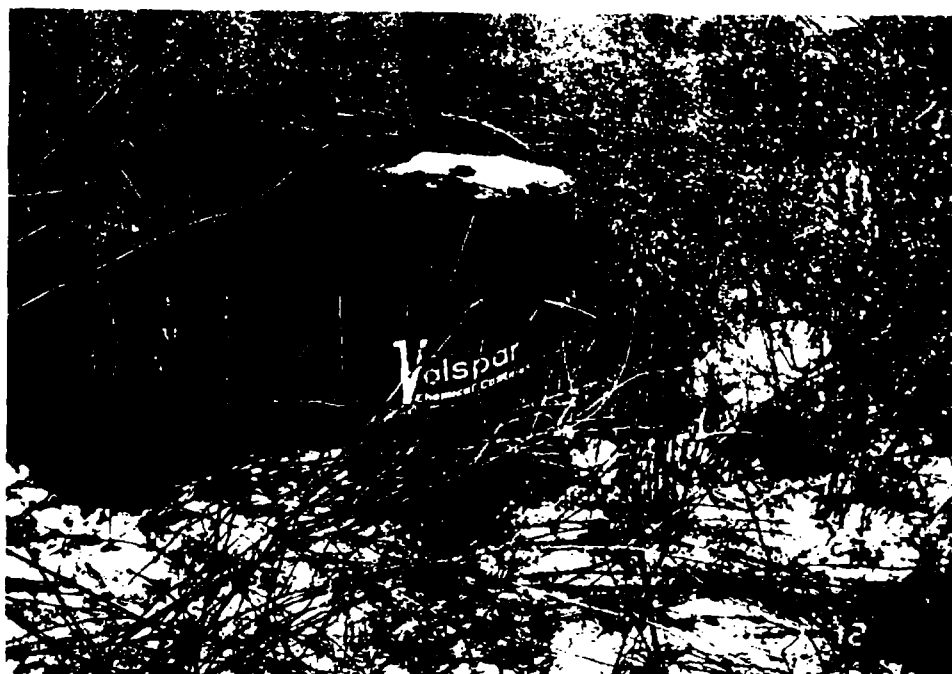
PHOTO NO: 23
 SITE: LYLE'S TRUCKING
 DATE/TIME: 01-12-90/PM
 DIRECTION: NORTH
 PHOTOGRAPHER: C. KREINDLER
 CAMERA: OLYMPUS INFINITY 35 MM
 SUBJECT: GROUP OF BARRELS ON-SITE

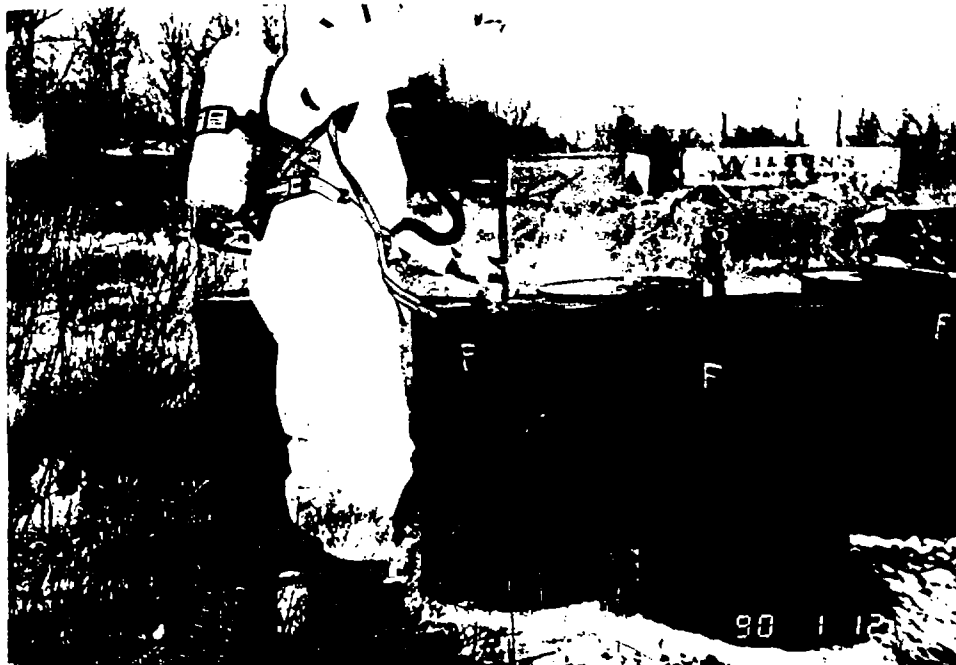
PHOTO NO: 24
 SITE: LYLE'S TRUCKING
 DATE/TIME: 01-12-90/PM
 DIRECTION: NE
 PHOTOGRAPHER: C. KREINDLER (Y)
 CAMERA: OLYMPUS INFINITY 35 MM
 SUBJECT: TAT COLLECTING DRUM SAMPLE D1

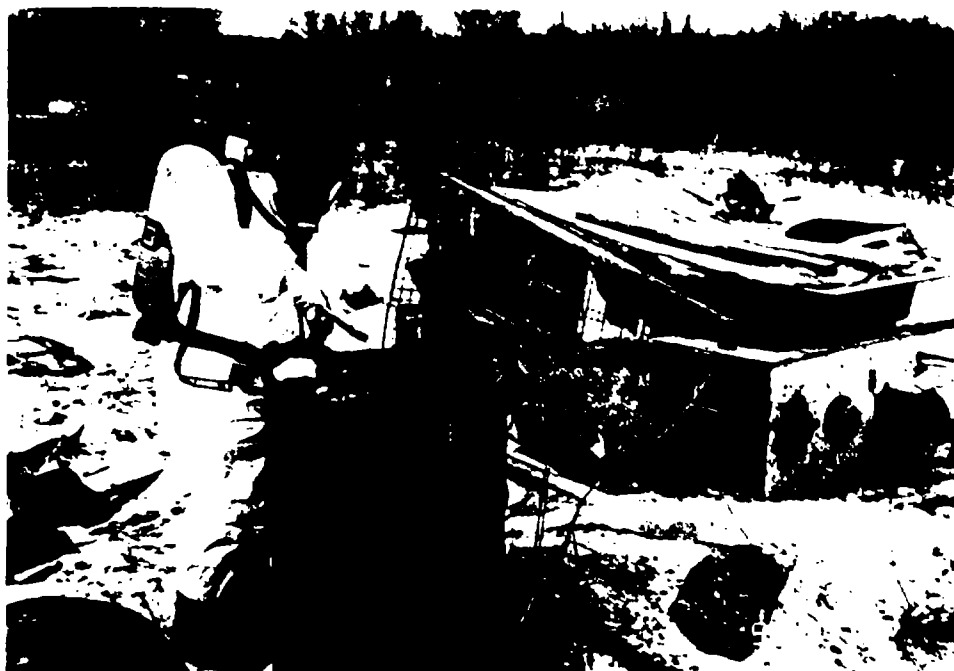
PHOTO NO: 25
 SITE: LYLE'S TRUCKING
 DATE/TIME: 01-12-90/PM
 DIRECTION: SE
 PHOTOGRAPHER: C. KREINDLER (Y)
 CAMERA: OLYMPUS INFINITY 35 MM
 SUBJECT: TAT COLLECTING DRUM SAMPLE D2

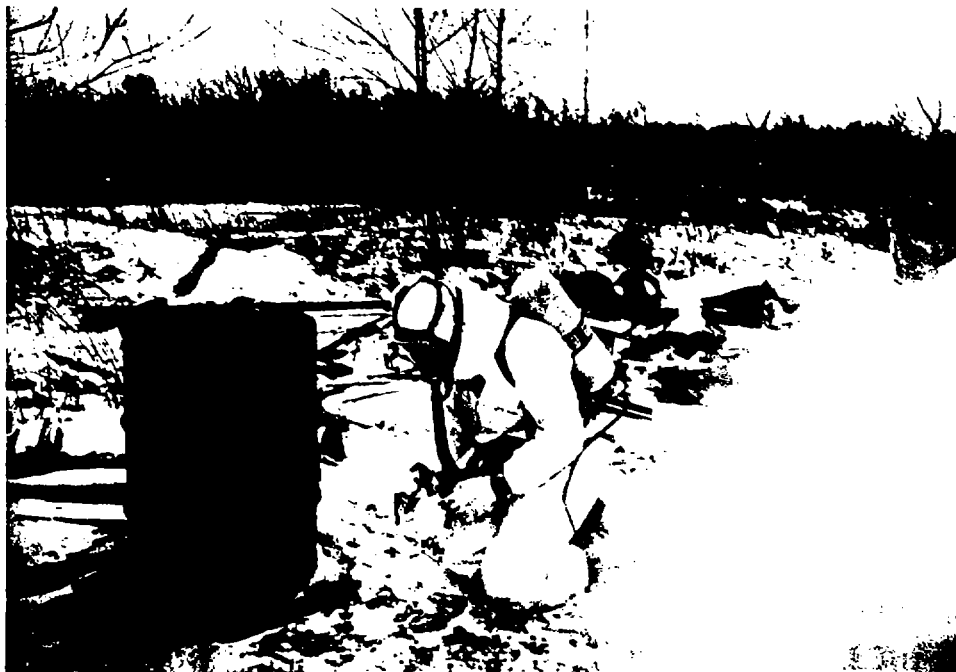
PHOTO NO: 26
 SITE: LYLE'S TRUCKING
 DATE/TIME: 01-12-90/PM
 DIRECTION: SOUTH
 PHOTOGRAPHER: C. KREINDLER (CY)
 CAMERA: OLYMPUS INFINITY 35 MM
 SUBJECT: TAT COLLECTING DRUM SAMPLE NO

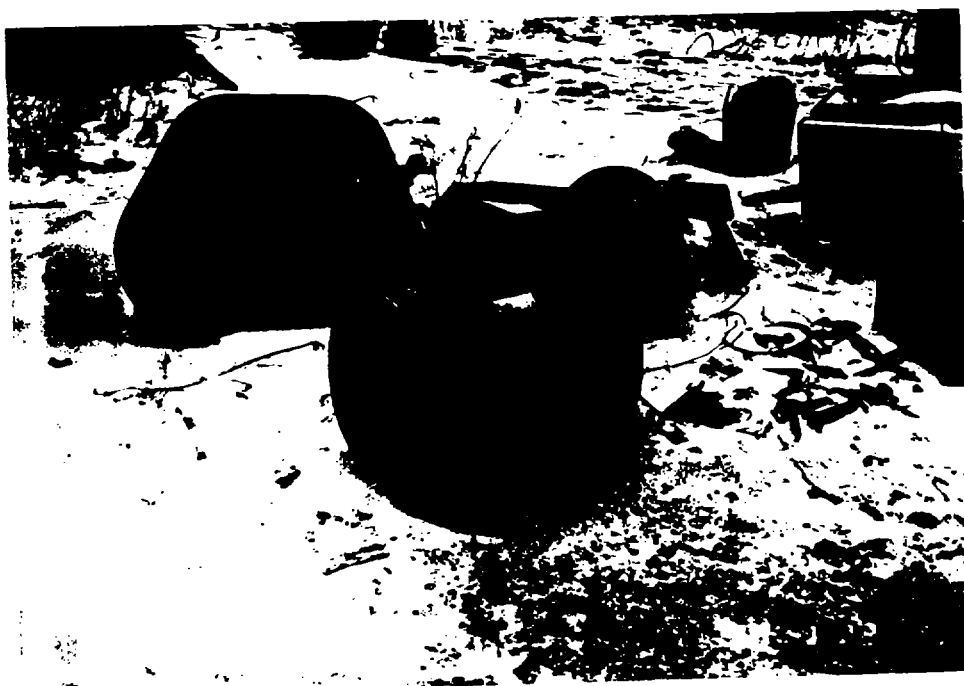
PHOTO NO: 27
 SITE: LYLE'S TRUCKING
 DATE/TIME: 01-12-90/PM
 DIRECTION: EAST
 PHOTOGRAPHER: C. KREINDLER (CY)
 CAMERA: OLYMPUS INFINITY 35 MM
 SUBJECT: VIEW OF FUEL TANKS CONTAINING LIQUID

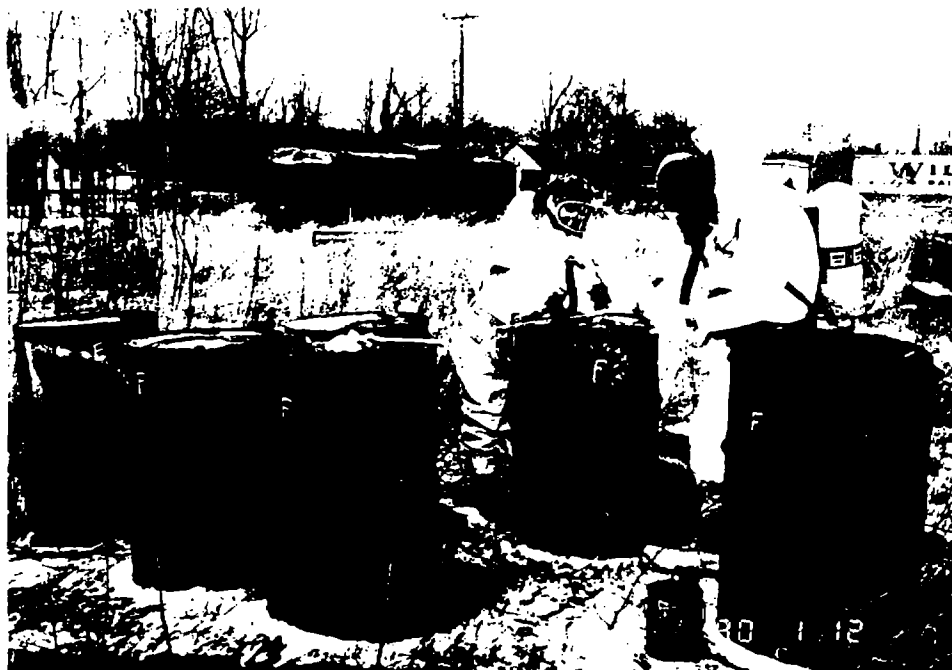
PHOTO NO: 28
 SITE: LYLE'S TRUCKING
 DATE/TIME: 01-12-90/PM
 DIRECTION: EAST
 PHOTOGRAPHER: C. KREINDLER (C)
 CAMERA: OLYMPUS INFINITY 35 MM
 SUBJECT: TAT COLLECTING DRUM SAMPLE D4
